Applies To:

All kingpost hang type hang loops manufactured between January 1, 2009 and August 25th, 2011. NOTE: THIS REVISION CHANGES THE BEGINNING OF THE DATE RANGE TO WHICH THIS INSPECTION REQUIREMENT APPLIES FROM SEPTEMBER, 2010 TO JANUARY 2009.

Service Requirement:

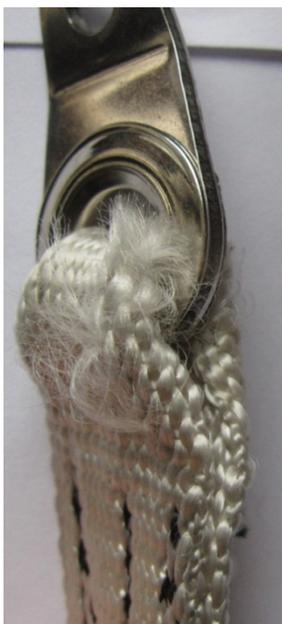
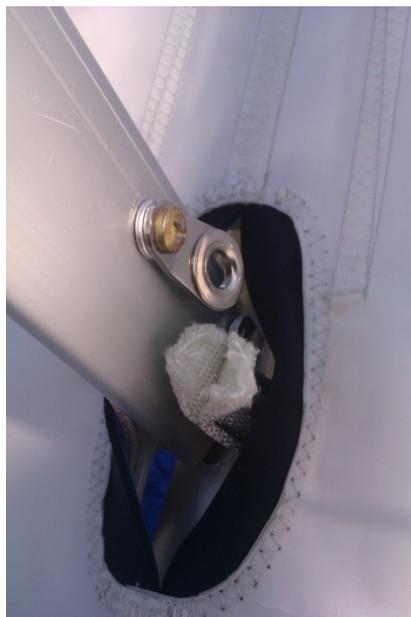
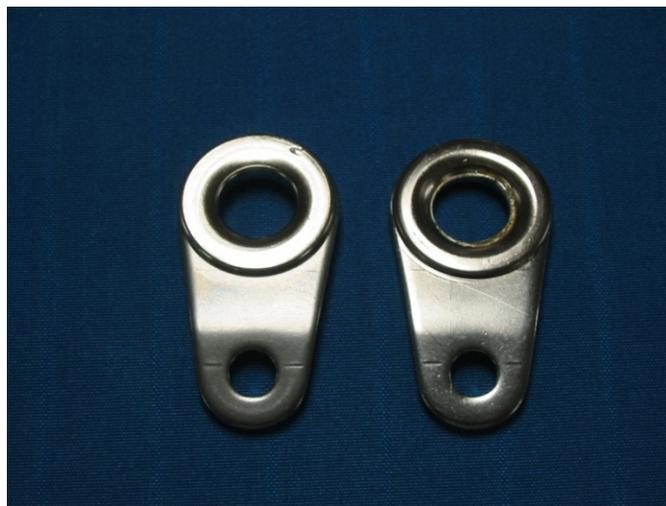
A customer recently discovered greatly accelerated wear on a hang loop where the loop attaches to the tang which is bolted to the kingpost on a U2 145. Current production models that use this type of hang loop are all U2's and all Sport 2's. Replacement hang loops manufactured since January 1, 2009 for other models using a kingpost hang system are also affected by this inspection – recall notice. We do not know the exact beginning of the time period to which the recall applies, but we know at least one defective loop was produced as early as March of 2009, so we recommend inspections of all loops made up to 3 months prior to that. The defective tool was replaced on August 25th, 2011, so the recall period ends on that date.

We have determined that the accelerated wear is caused by a defective grommet installed in the hang loop tang which is the result of a damaged grommet setting tool. NOTE: BECAUSE THE DEFECTIVE GROMMET IS THE RESULT OF DAMAGE TO THE GROMMET SETTING TOOL, IT IS LIKELY THAT THIS DEFECT APPLIES TO EVERY HANG LOOP PRODUCED SINCE THE TOOL WAS DAMAGED. THERE HAS BEEN AT LEAST ONE COMPLETE FAILURE OF A HANG LOOP SINCE THIS RECALL WAS ISSUED (center photo below). The photo on the left below shows the damage to the hang loop, and the photo on the right shows a correct grommet – tang installation on the left, and a defective installation on the right, where there is a sharp edge on the inside of the installed grommet.

It is IMPERATIVE that every hang loop produced during this period be inspected and that every defective hang loop be replaced.

Inspect the hang loop carefully for any sign of wear at the attachment to the tangs, and inspect the grommets installed in the tangs for any sharp edges. If you find wear on the hang loop, or sharp edges on the grommet, the hang loop will need to be replaced.

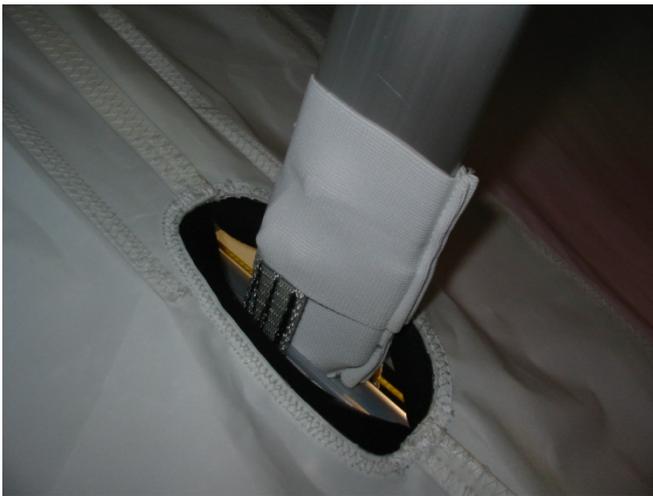
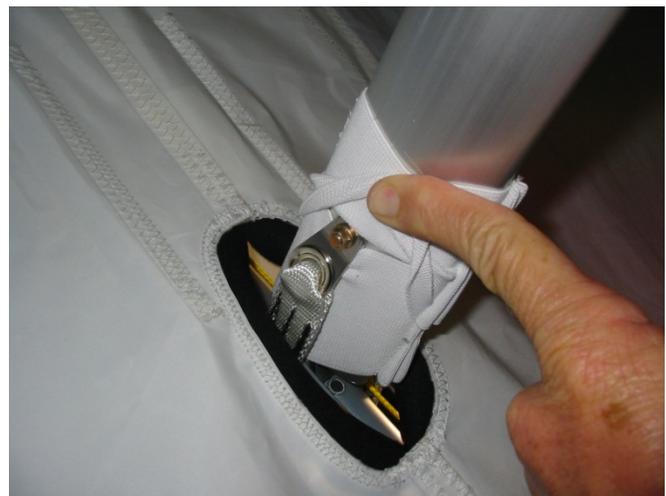
Note that there are two factors which may prevent one from noticing the defect on casual inspection – one, the hang loop tang is normally covered up by the protective kingpost base sock, and two, the defect on the hang loop tang grommet may be on the inside of the tang, not easily visible unless the hang loop is removed from the kingpost so that the inside of the tang can be inspected.

Peel back the protective sock to expose the bolt head and clinch nut that secure the hang loop to the kingpost. Remove the ¼ inch clinch nut from the bolt, remove the bolt from the kingpost, and dismount the hang loop from the kingpost. Note that there are two loose bushings inside the aluminum bushing that is permanently installed in the kingpost – take care not to misplace these.
